# Manhole Inspection Summary

Manhole # S15AA\_041MH

Insp Date: **11/19/07 9:40 AM**

**Location** Address: **REAR OF 933 ASHBURTON ST**

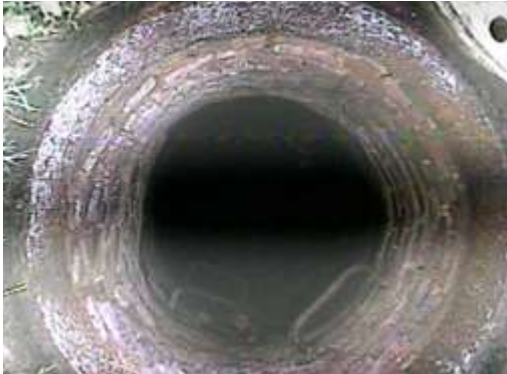
Top View

CORRODED STEPS

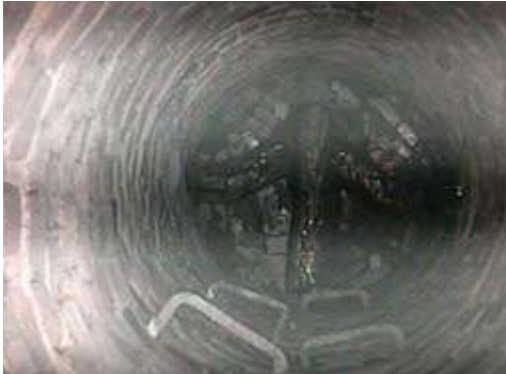
Defect 1

Count: **7** Missing: **0** ☒ **Corroded**

CORRODED STEPS

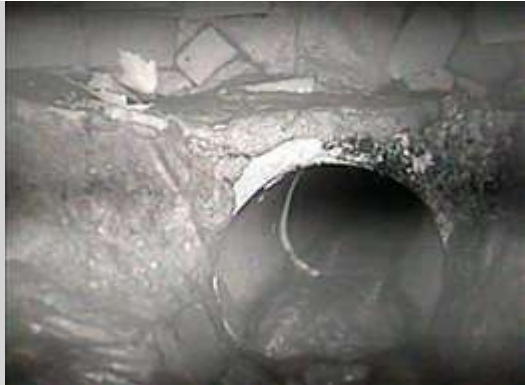
12 O'Clock Outflow

10 in. Circular Gravity Sewer  
Pipe Out @ 12 O'Clock

Pipe Height: (in.) Direct  
Pipe Material: **Clay** ☐ Pipe Lined  
Invert Depth: **12.62** (ft.) Flow Characteristics: **Slow**  
Deposits: ☒ None ☐ Mud ☐ Sludge ☐ Debris ☐ Grease  
Silt Depth: (in.) Deposits Extent:  
Infiltration: **None** Pipe Seal Cond: **Sound**

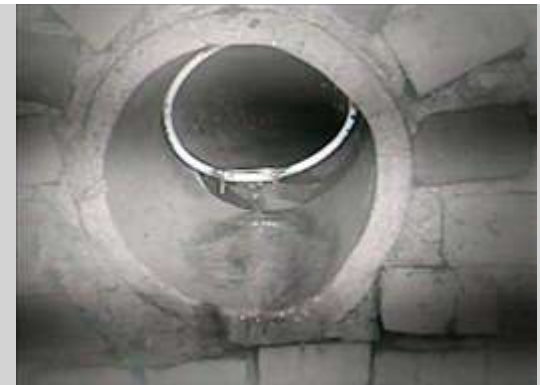
3 O'Clock Inflow

10 in. Circular Gravity Sewer  
Pipe In @ 3 O'Clock

Pipe Height: (in.) Direct  
Pipe Material: **Clay** ☐ Pipe Lined  
Invert Depth: **8.76** (ft.) Flow Characteristics: **None**  
Deposits: ☒ None ☐ Mud ☐ Sludge ☐ Debris ☐ Grease  
Silt Depth: (in.) Deposits Extent:  
Infiltration: **None** Pipe Seal Cond: **Cracked**

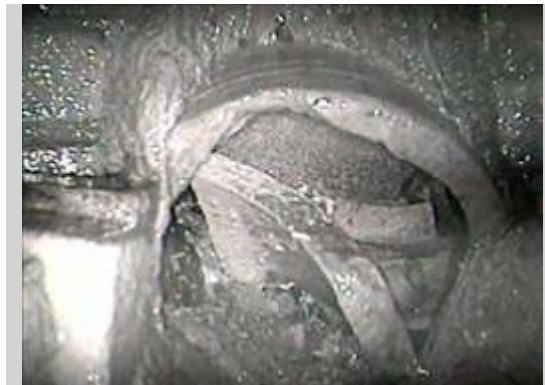
Drop In @ 3 O'Clock

Drop: **Outside Direct**  
Angled: Reading: (ft.)  
Inv Depth: **12.36** (ft.)  
Drop Condition: **Open**

Connects To: **Stub connection / abandoned**

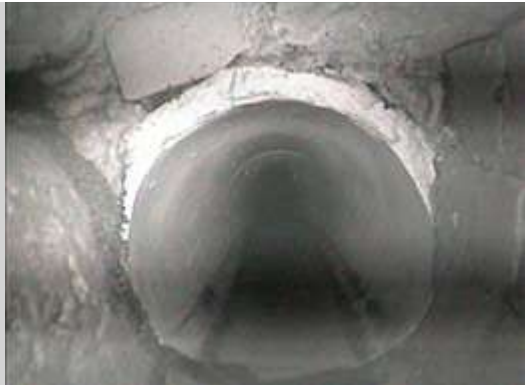
6 O'Clock Inflow

Pipe In @ 6 O'Clock

Infiltration: **None** Pipe Seal Cond: **Sound**

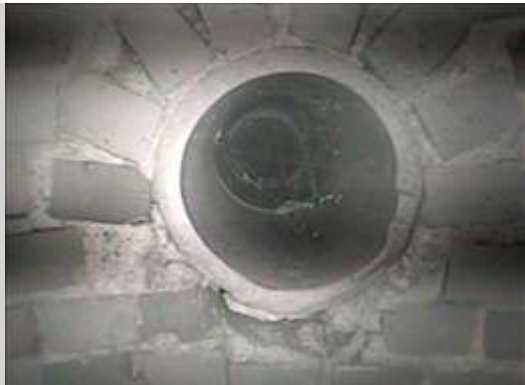
9 O'Clock Inflow

Pipe In @ 9 O'Clock

Infiltration: **None** Pipe Seal Cond: **Sound**

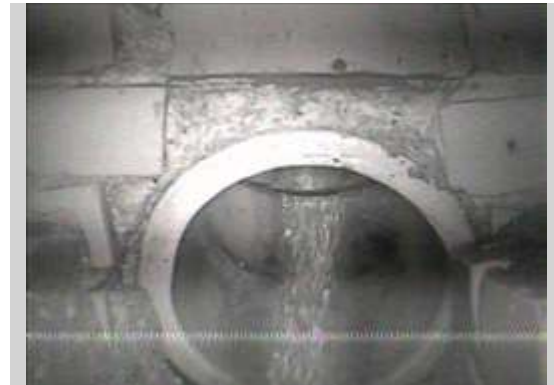
Drop In @ 9 O'Clock

Drop: **Outside Direct**

Drop Condition: **Open**

Connects To: **House connection / Service line**
